### 2.1 Minutes of the Ordinary Meeting 16 April 2020

<b>Date of meeting</b>	28 May 2020
<b>Agenda item number</b>	2.1
<b>Author/s</b>	Jo Clark – Council Secretary

CHATHAM ISLANDS ROAD  
MAINTENANCE CONTRACT  
MONTHLY REPORT  
April 2020

WATER AND  
WASTEWATER  
OPERATION CONTRACT  
MONTHLY REPORT  
April 2020

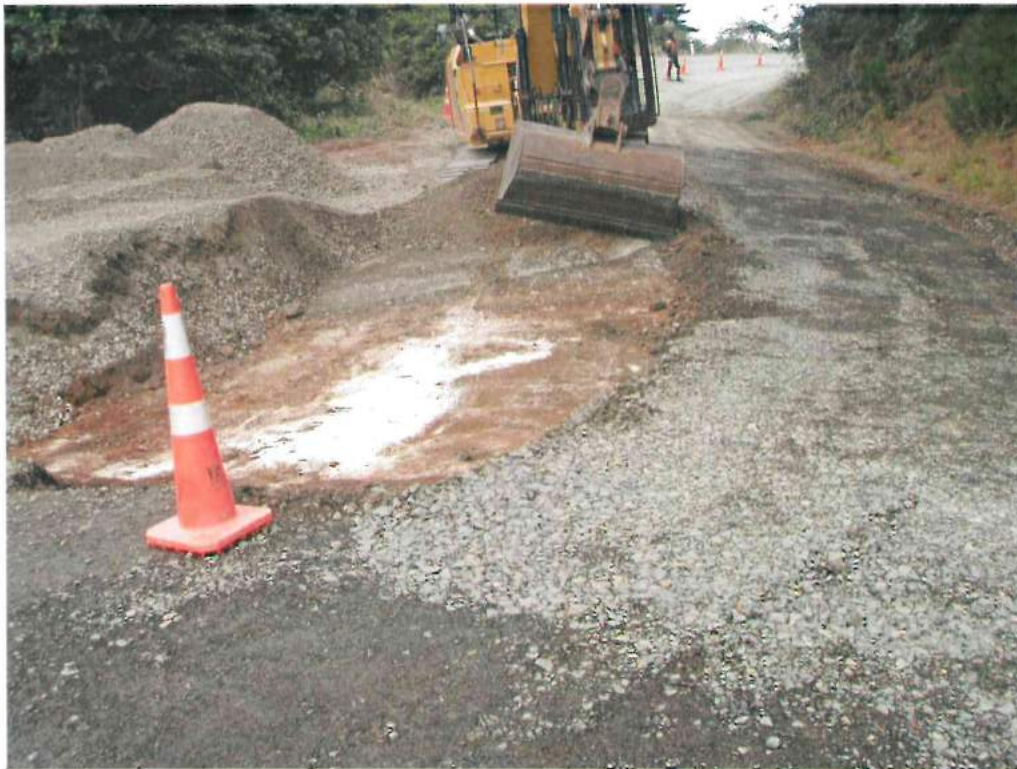
Te Awainanga

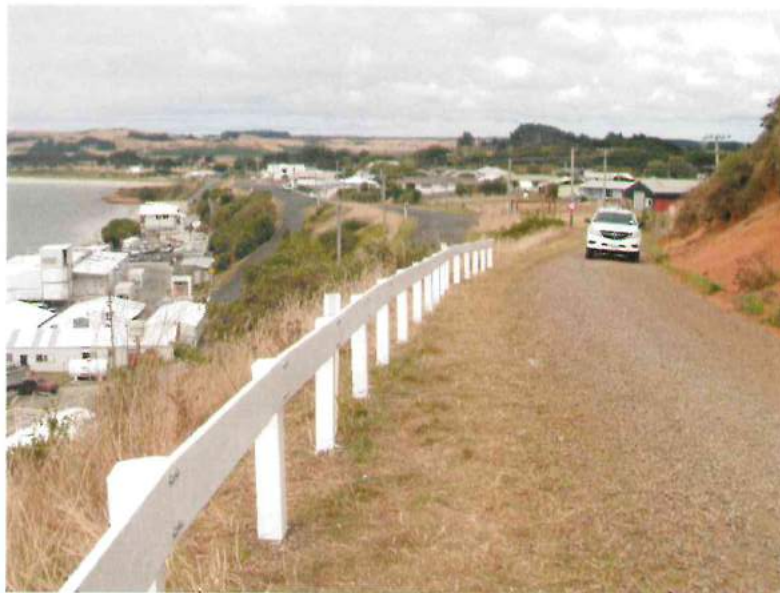
Tiki Tiki Sight Rail

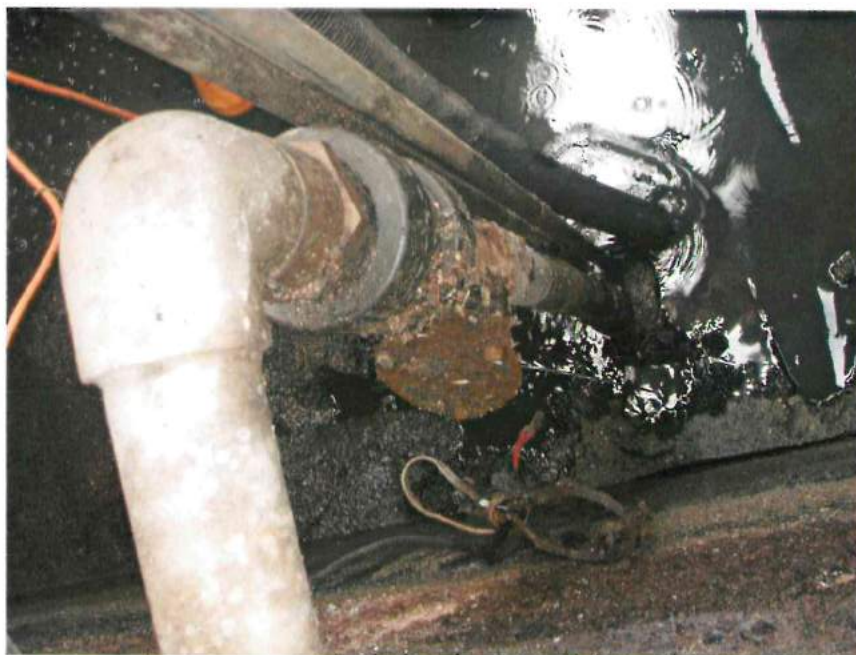
Corroded check valve at main pump station

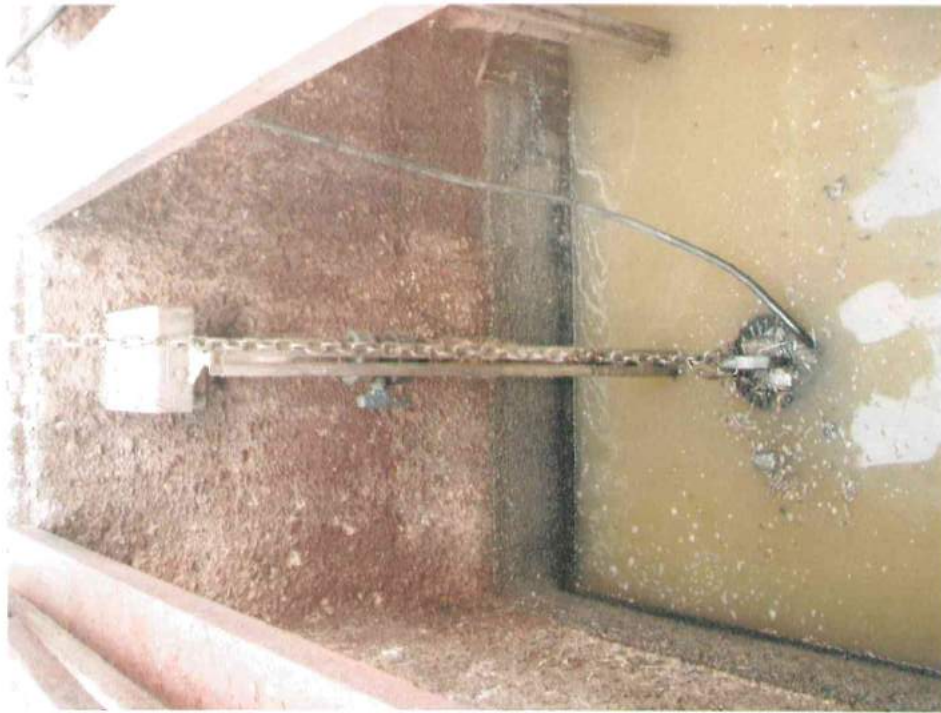
Faulty pump in wet well

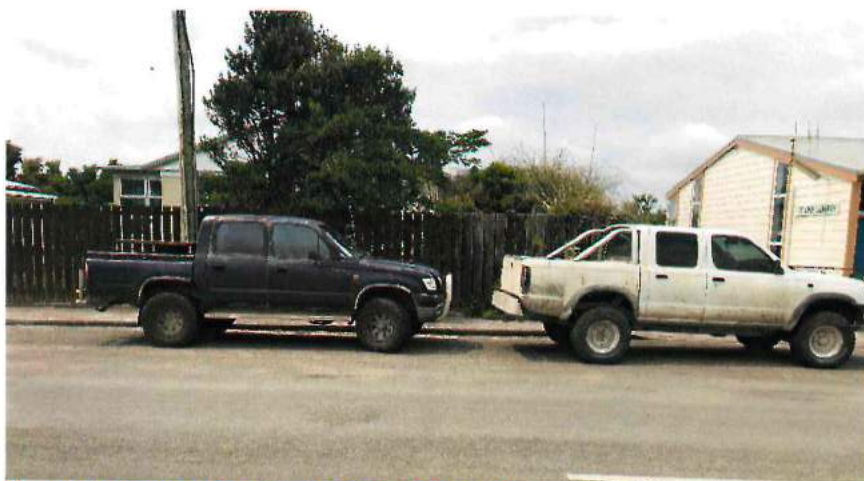
Figure 2-1: Proposed Crossing Location – School Side

The proposed crossing location is at the Northern end of the school / Southern end of the angle parking outside the Church as shown in Figure 2-1 and Figure 2-2. An alternative location is slightly further South, on the southern side of the school and opposite private accessway, however this location is more difficult to provide street lighting at and decreases the available visibility to the south.

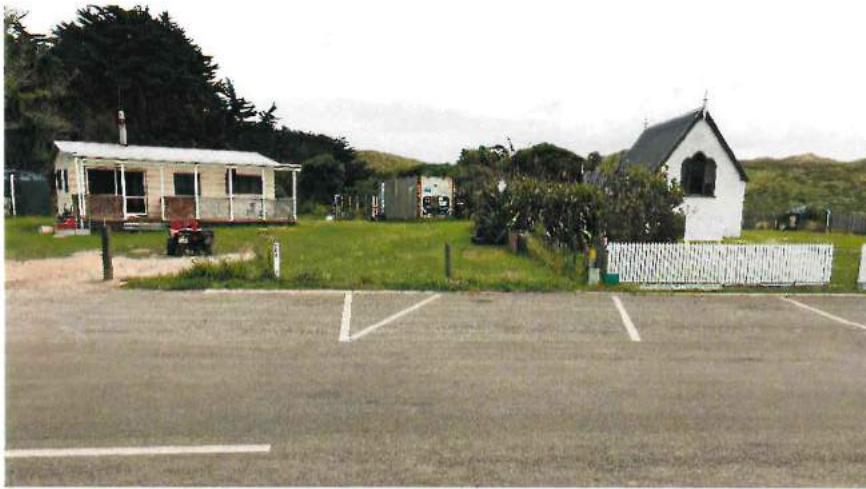
Figure 2-2: Proposed Crossing Location – Church Side

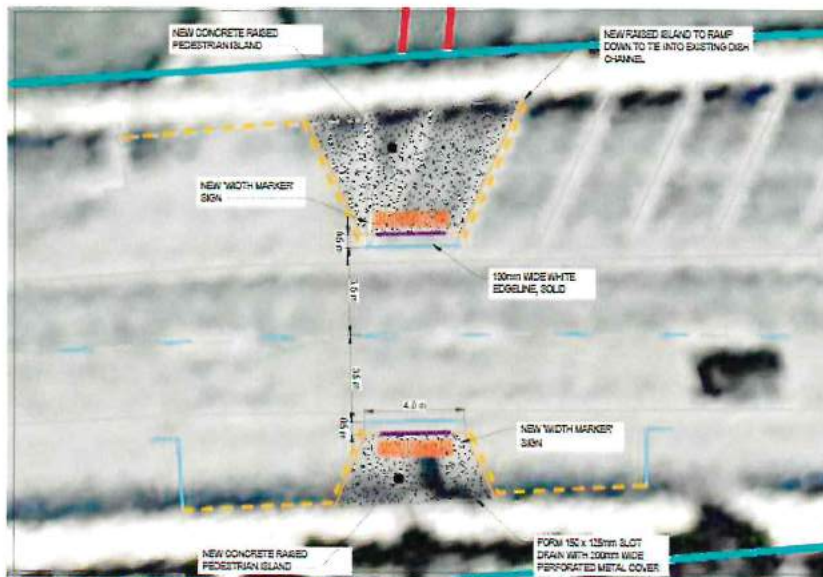
Figure 3-1: Pedestrian Buildout Island

An added benefit is the buildouts create a narrow point in the road, which would act to increase the side friction felt by drivers, resulting in a potential reduction in vehicle speeds.

This option creates an informal pedestrian crossing point, where the pedestrian does not have the right of way and drivers do not have to stop for pedestrians.

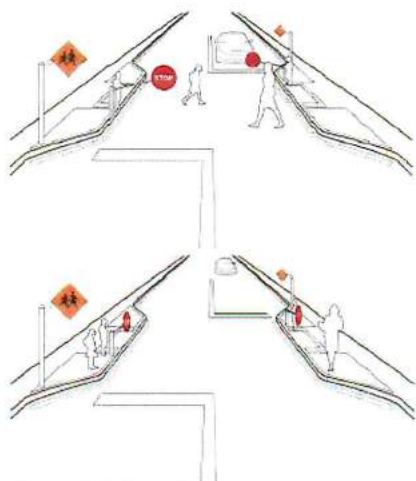
Figure 3-2: Kea Crossing

This option would involve installing the same kerb buildouts as per Option 1 with the additional signage and marking package required to enable a formal School Patrol to operate, as shown in Figure 3-2.

A Kea Crossing requires the buy in and co-operation of the school, with the need for the crossing point to be actively operated by a supervising adult and two senior school age children.

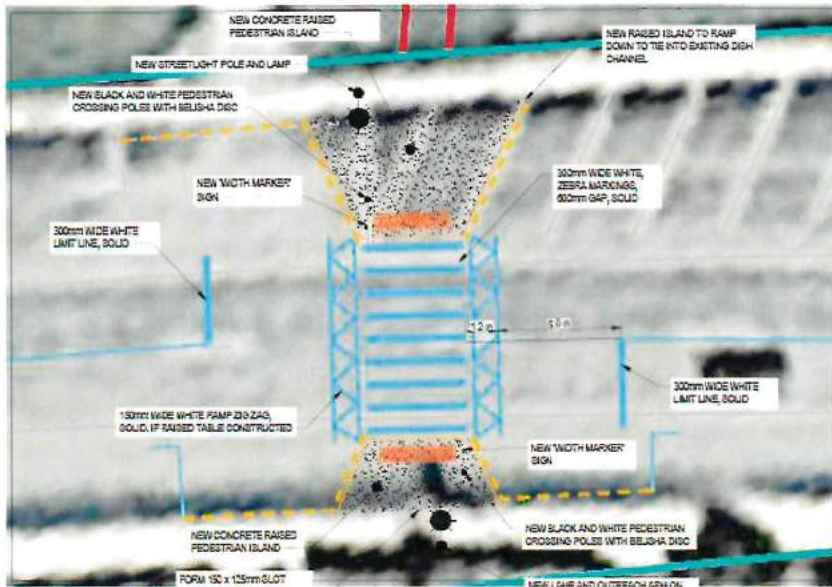
Figure 3-3: Zebra Crossing

This option would involve installing similar kerb buildouts as per Option 1, plus the additional signage, markings and street lighting, to upgrade the crossing to a formal zebra crossing (some of which is displayed in Figure 3-3). With a zebra crossing the formal controls that require motorists to stop for pedestrians are always active during day and night. Therefore, to ensure visibility of pedestrians, the pedestrian crossing must be well lit during the hours of darkness. This would require the installation of two new street lights at this location.

Zebra crossings in locations such as this, with a normally low to very low pedestrian demand, can create a safety issue. Motorists who regularly drive through these crossings can become complacent and assume pedestrians will not be present. The safety issue arises when a pedestrian expects they can safely step out onto such a pedestrian crossing, and a motorist due to familiarity assumes no one will be using the crossing.

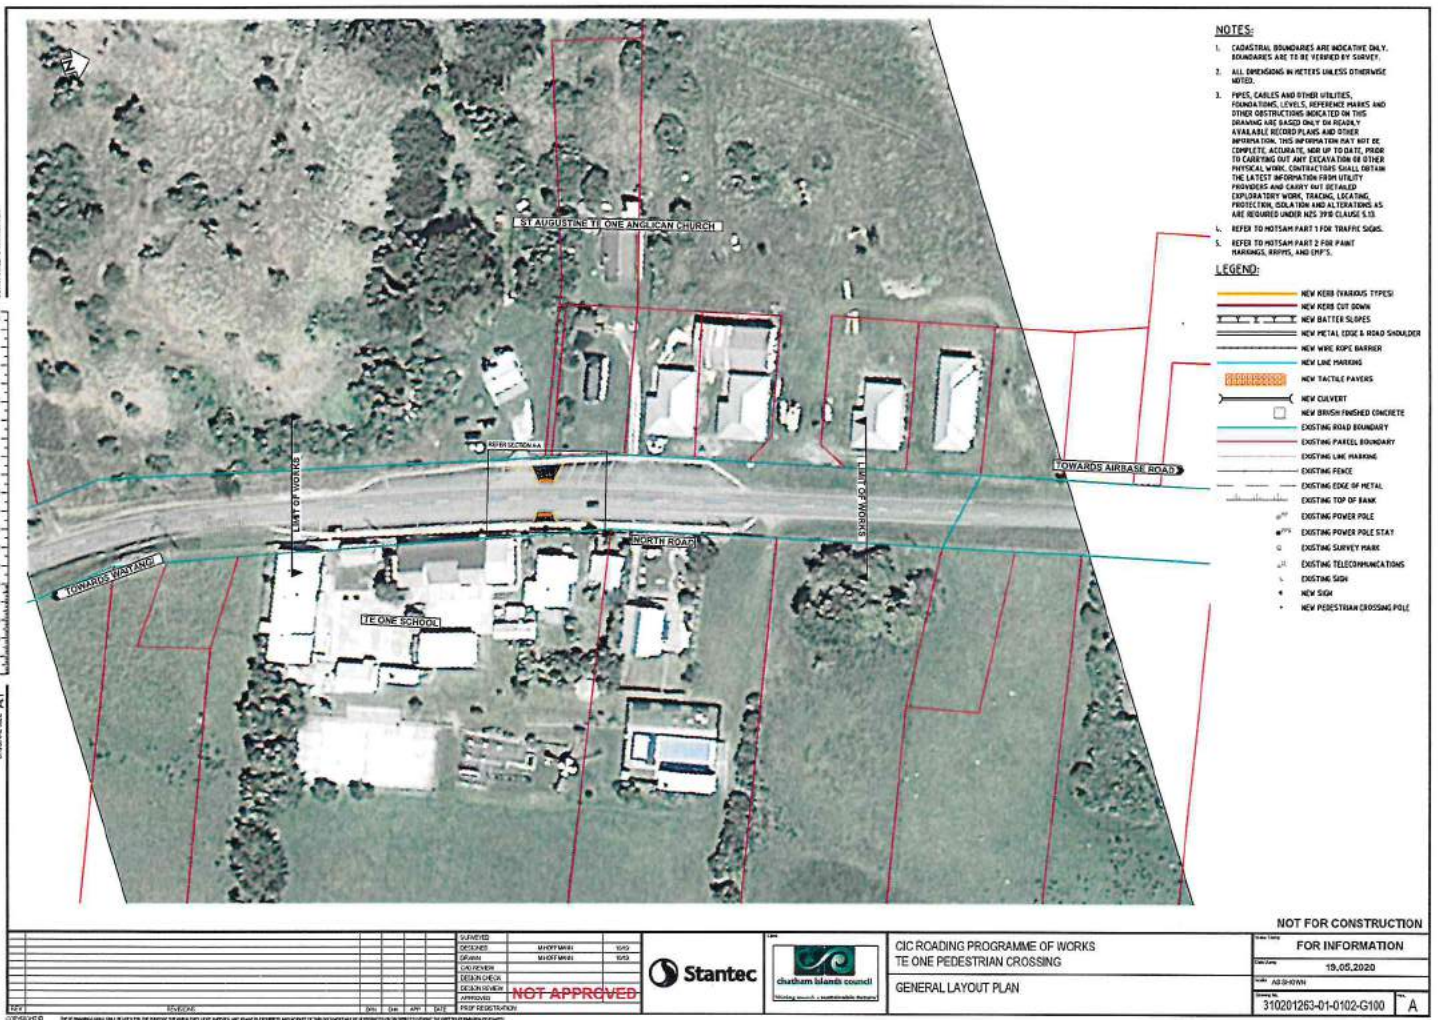
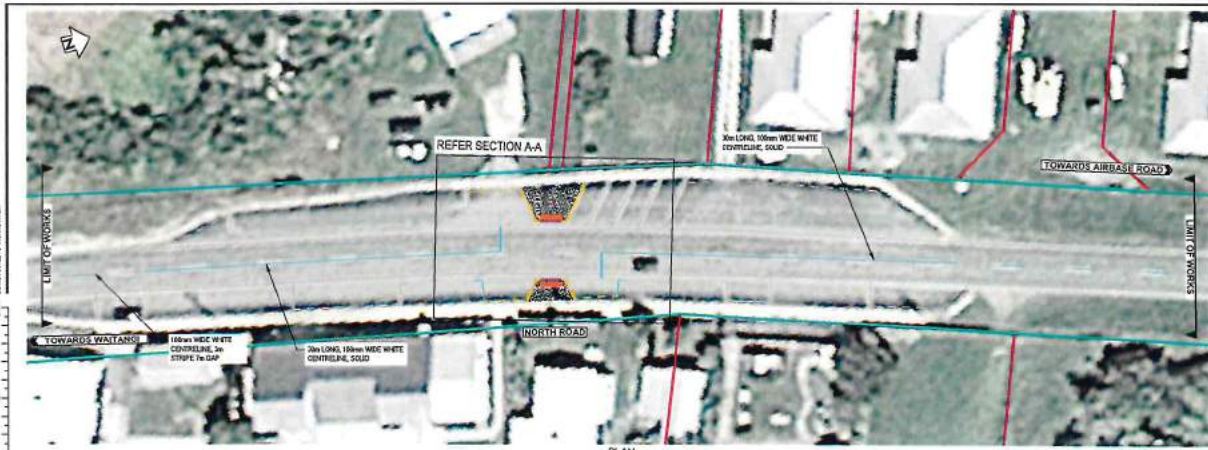
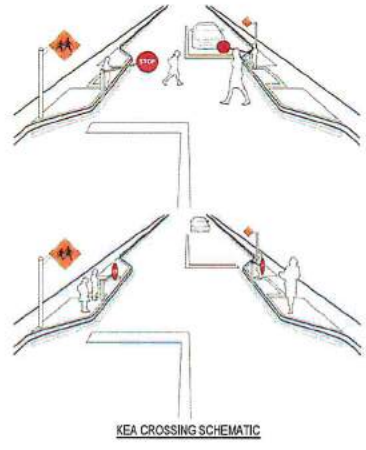
CIC ROADING PROGRAMME OF WORKS  
TE ONE PEDESTRIAN CROSSING  
LAYOUT PLAN  
OPTION 2 - KEA CROSSING

PLAN  
SCALE 1: 250

Option 2 – Kea Crossing without the raised platform is our preferred solution, so long as there is buy-in from the school and school community to operate the required school patrol. If there is no desire from the school to run a school patrol then Option 1 is the next recommendation.

Stantec recommends that we proceed to detailed design of Option 2, with the view to permanently construct the kerb buildouts, signage and markings in the next construction season. Consultation with Te One School can also begin around the implementation of a School Patrol.

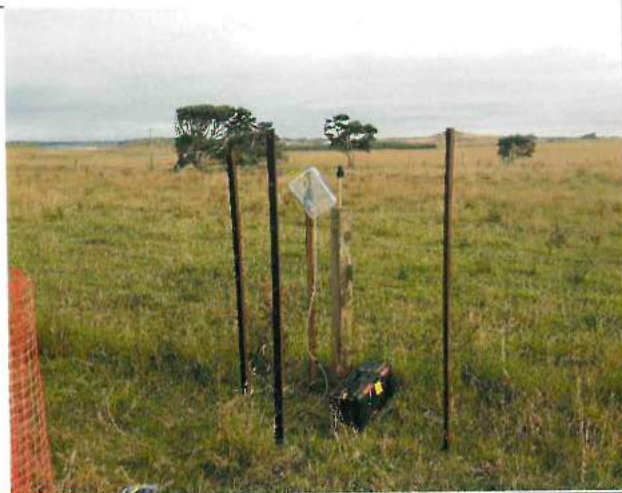
Picture 1 North Sampling Site, Schist

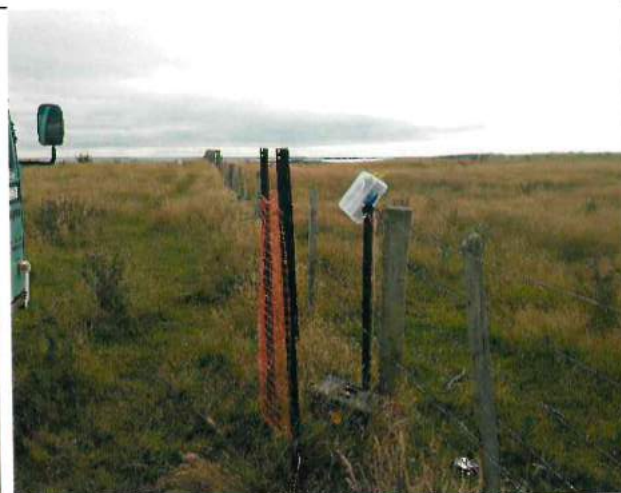
Picture 2 South Sampling Site, Basalt

- Basalt is used in areas adjacent to houses or buildings as its crystalline silica content is lower
- Results suggest its dust is also more suppressed by wetting than schist
- Residents may still be exposed to high respirable dust levels in dry conditions
- Stantec staff reported that basalt stones and pebbles can be more easily thrown from the road by vehicles than schist, resulting in higher required maintenance
- Conditions on the island were relatively dry while K2 staff were on the island; this is reflected in high respirable dust levels in the early stages of monitoring at both sites
- Rain in the later stages of testing (28-29<sup>th</sup> January), however preceded overall lower respirable dust levels at the site where basalt was the adjacent road material

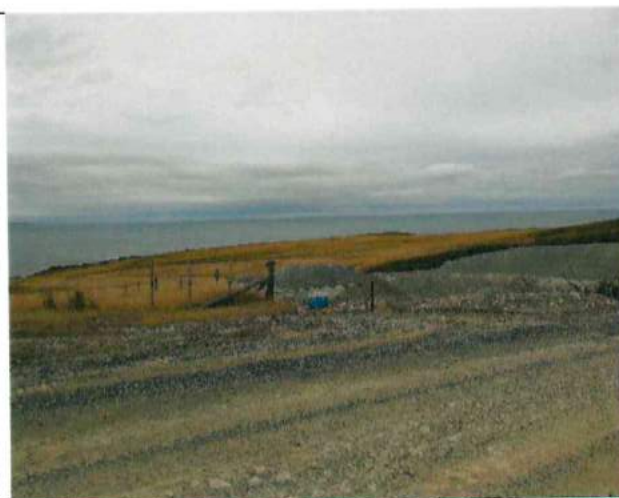
Picture 3 Fulton Hogan Crushing Plant

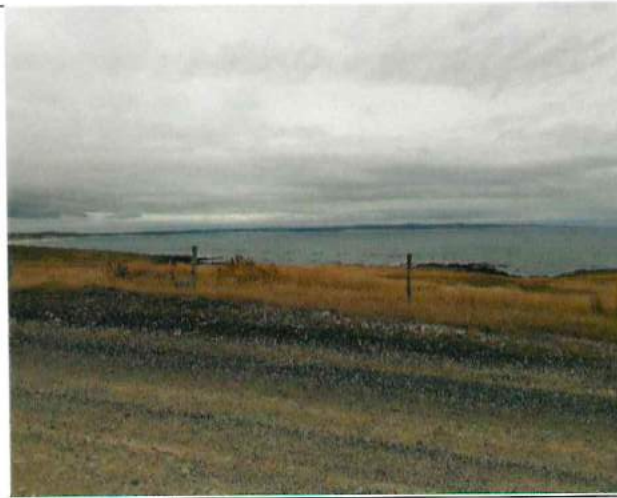
Picture 4 Schist Roding, Port Hutt Road

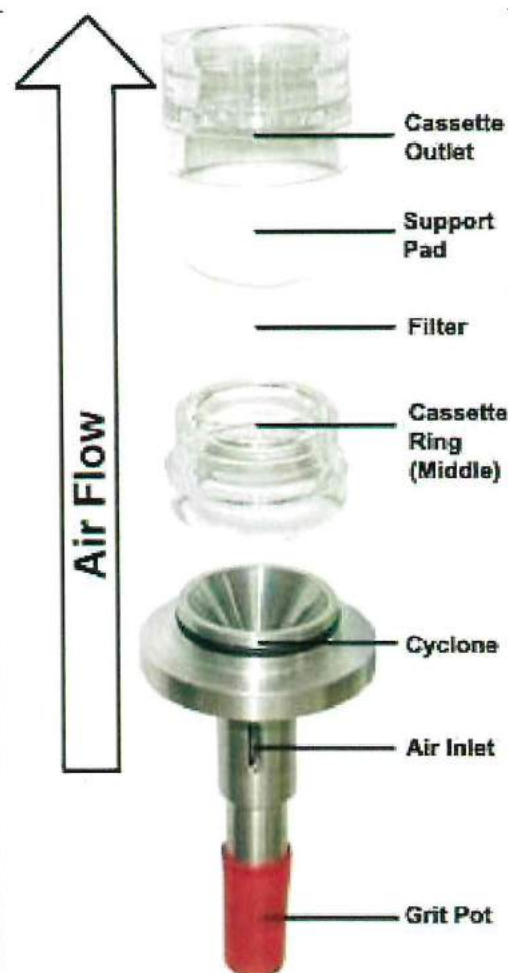
The following method is used to measure the respirable dust collected for RSC determination: NIOSH 7500 – Silica Crystalline by X-Ray diffraction. Sample is analysed on the filter.

The filter is reweighed for gravimetric determination of the respirable dust.

The filter is then sent to an accredited laboratory to determine silica concentrations.
