Habitat mapping of Te Whanga Chatham Islands

**A summary report
of data collected in March 2009**

June 2009

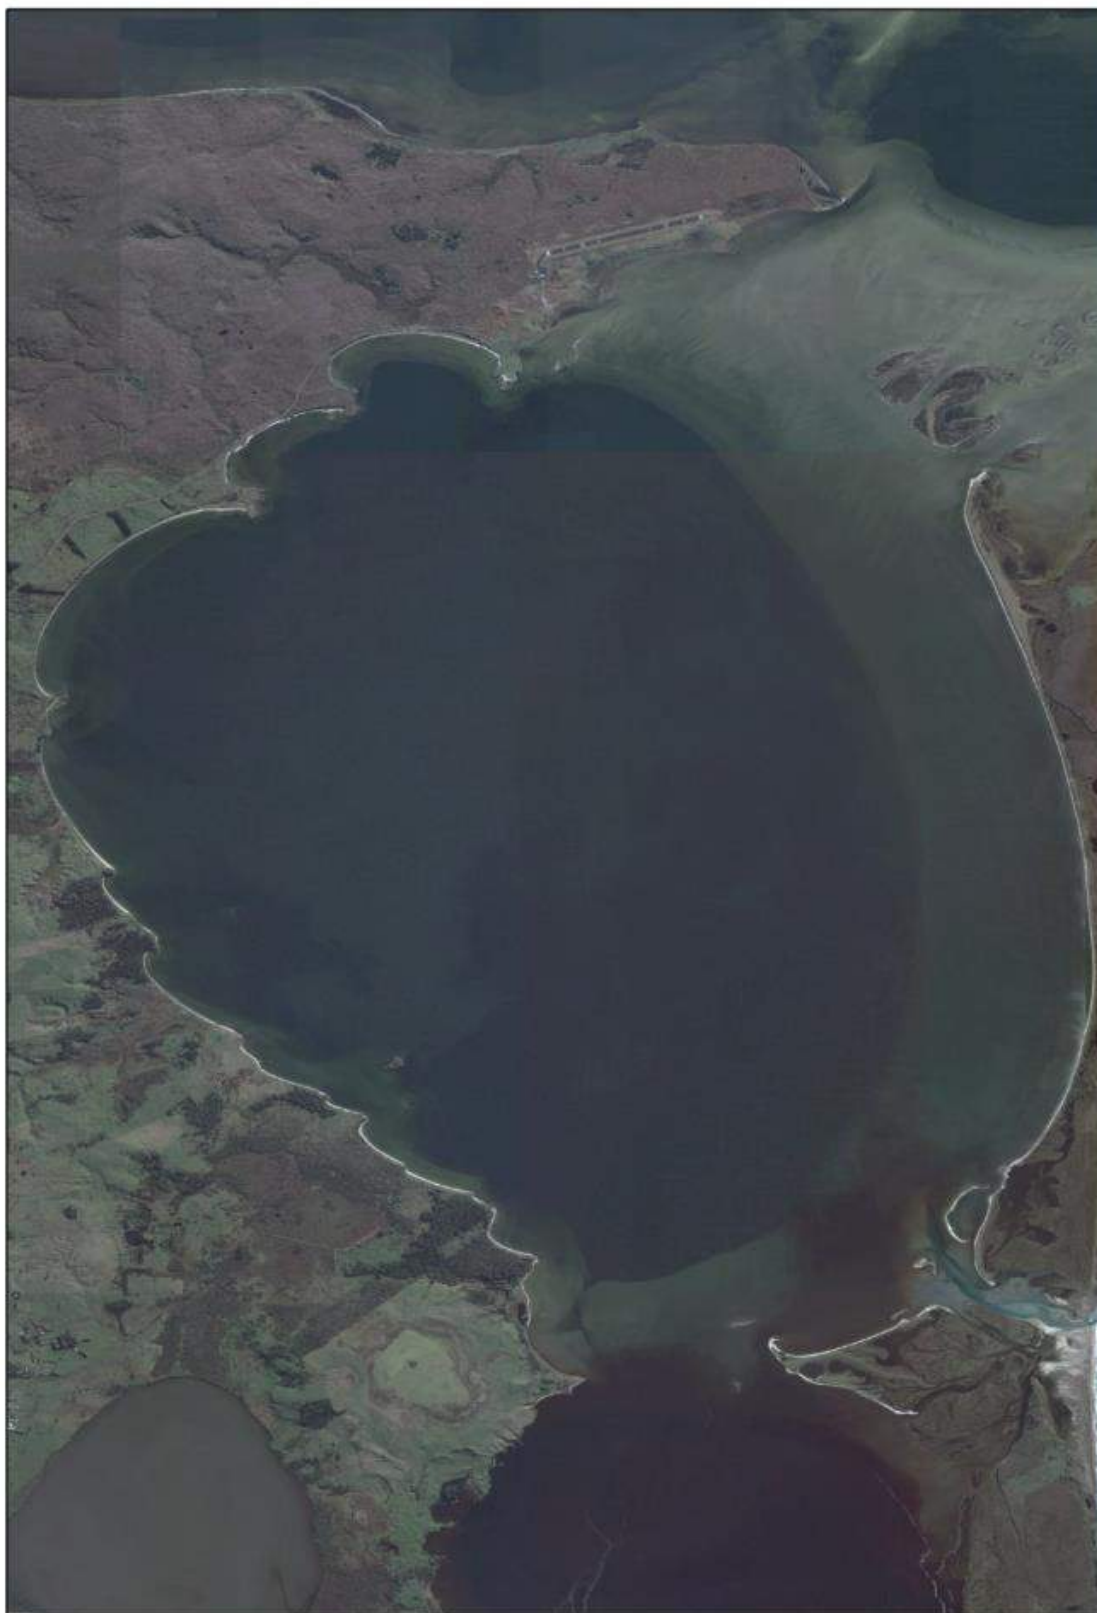
Figure 2 Satellite image of the central basin (Projection: World Geodetic system 1984)

The assessment of the habitats (see Appendix I for details) of the margin and shallow subtidal areas of the central basin (Figure 2) was carried out over 18-22 March 2009. In addition to habitat assessment the following data were collected:

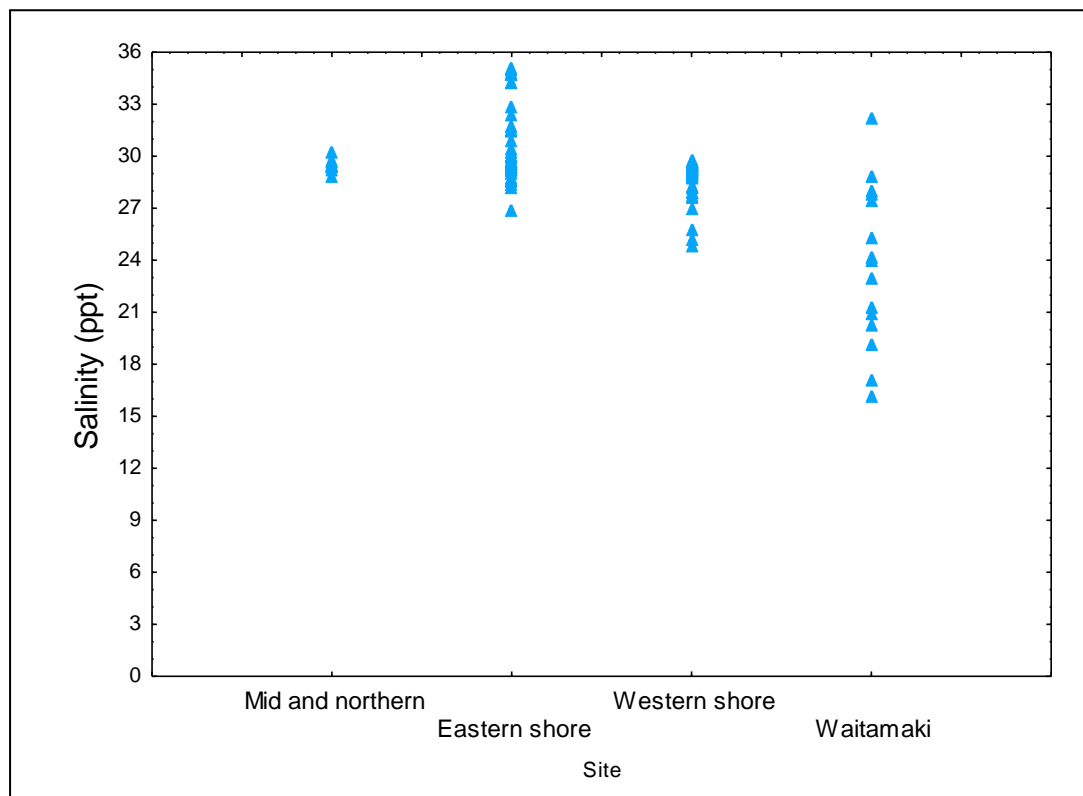
Figure 12 Salinity (ppt) in the central basin

Salinity was measured at many sites around the shore of the central basin. In addition salinity was measured at sites in the northern shallow subtidal area, sites in the middle of the central basin and at sites in the south basin. The salinity at a water depth of 20-30 cm was typically measured. However, where there was a distinct layering in the water column the salinity of both the surface and bottom water was measured. The salinity results for the central basin are shown in Figure 12. The data were grouped by site location, i.e. western shore, eastern shore and from the northern end and centre of the basin. In addition salinity data collected quarterly since 2005 from the western shore of the central basin at Waitamaki Creek, Airbase Road were plotted.

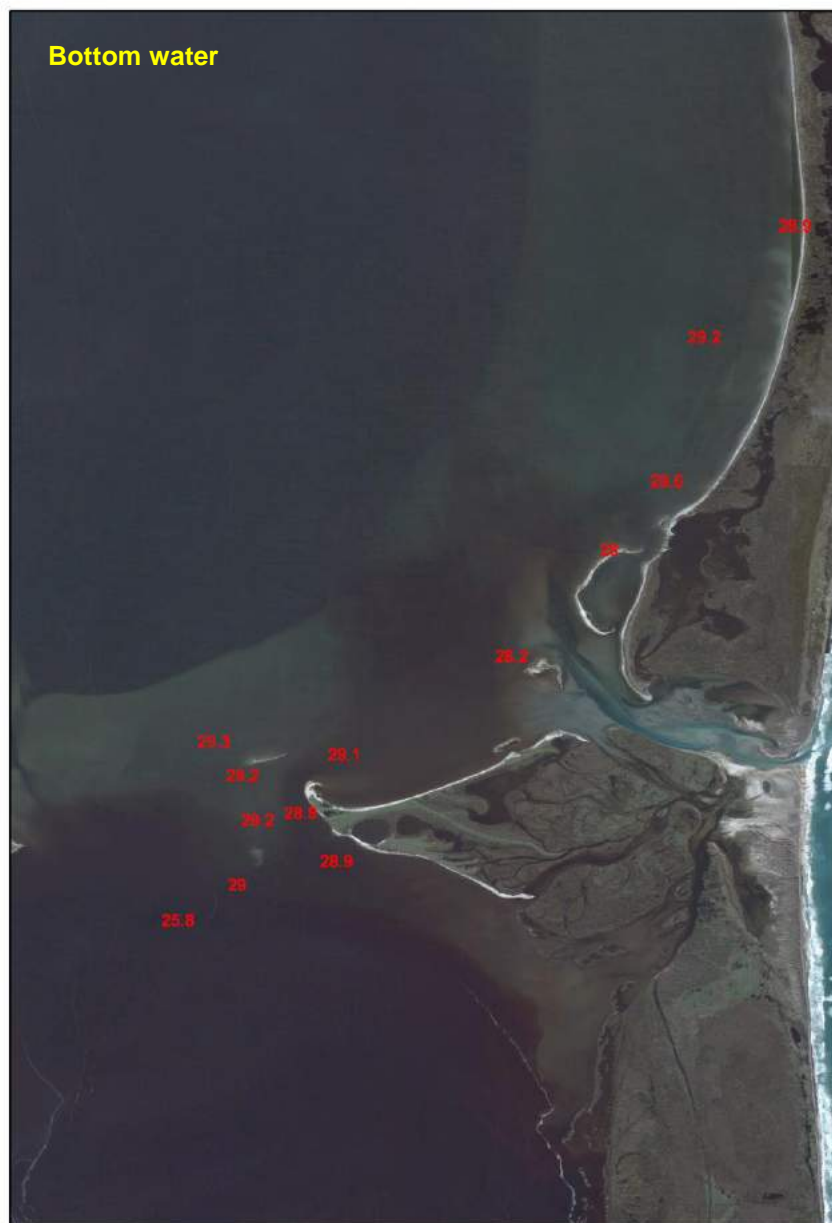
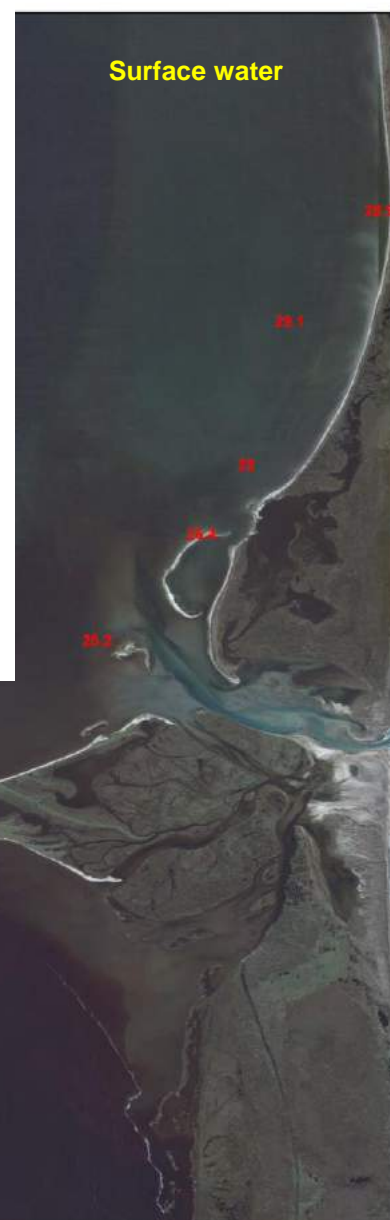
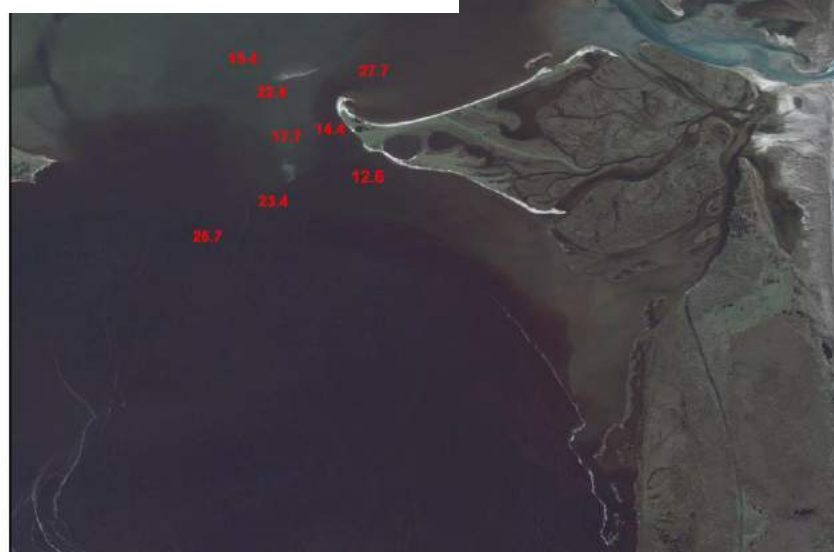
Figure Salinity (ppt) in surface water and bottom water at some sites

At some sites between the central and south basin and in the south basin there was a difference in salinity between surface water and bottom water. Thus salinity was measured at both water depths (Figure 14). The results show that there was fresher water layer over a more saline layer. However, the fresher water layer did not have a salinity close to zero, that is it is still a mix of fresh and sea water.
