Title: Waitangi Wharf Coastal Process Monitoring Report					
Date	Version	Description	Prepared by:	Reviewed by:	Authorised by:
23/12/20	1	First Issue	Michael Paine	Tom Shand	Ed Breese

Waitangi Wharf Coastal Processes Monitoring Plan

Waitangi Wharf Upgrade – Coastal Processes Report

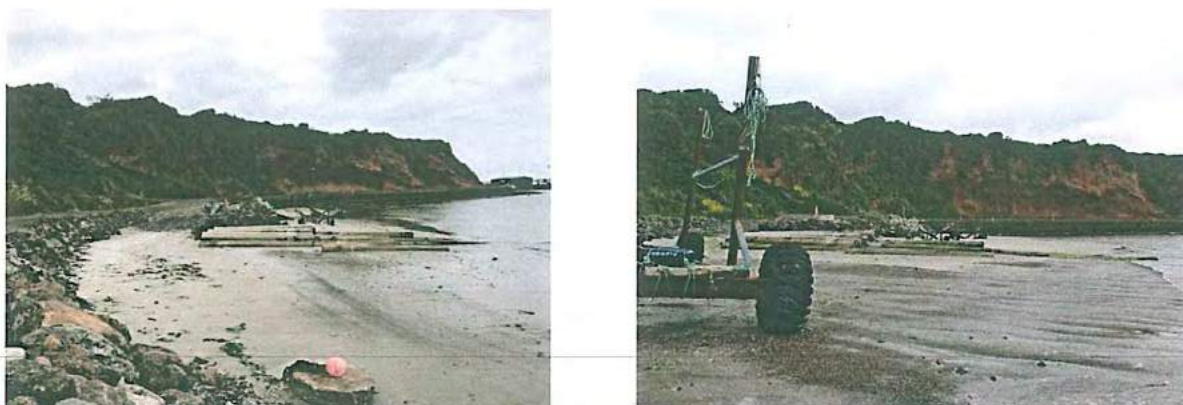
The sand levels at the far western end of Towns Beach, west of the concrete pile groyne appear unchanged between the December 2019 and 2020 monitoring rounds. There is erosion along the access road edge which will likely continue unless protected. The higher beach levels at this location (compared to pre-nourishment) will be somewhat aiding in mitigating the rate of erosion. Sand build-up on the western side of the groyne and reduction of the sand levels on the eastern side was noted during the 2018 monitoring rounds and this difference in beach levels was also evident during the 2020 monitoring round (refer Figure 3-2).

Figure 3-2: Beach photo-point monitoring at point 1 Dec 2018 (left) and Nov 2019 (right)

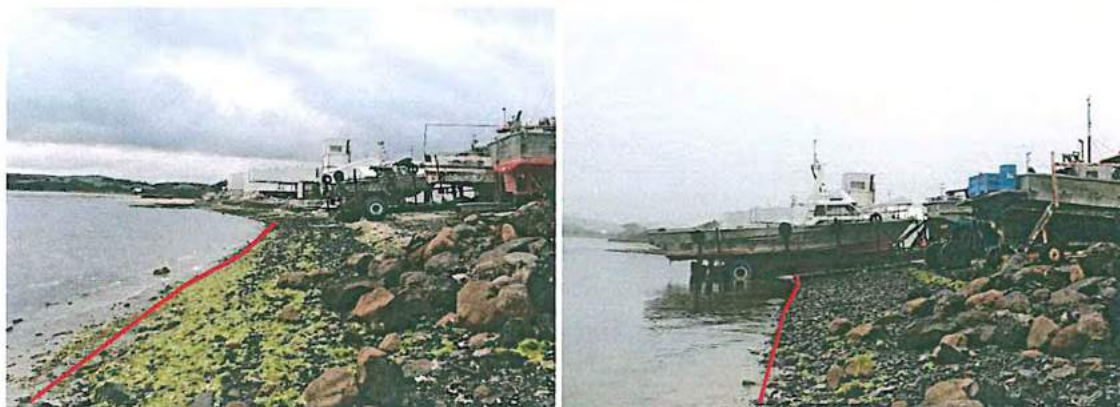
In 2019, the sand levels were noted to be visibly lower at the upper beach location at the western end of Town Beach adjacent to the boat haul out area and new ramp extension than in 2018. The beach levels at this location are currently similar to those in 2019 with the sand levels not rebounding. These changes are clear in photos taken at monitoring point P1 and P2 as well as in the survey profile at location T2 (refer Section 3.3). The gravel/sand interface at the top of the beach has retreated landward since 2019 see Figure 3-3. This gravel was exposed between 2018 and 2019.

Figure 3-3: Beach photo-point monitoring at point 2 Dec 2019 (left) and Dec 2020 (right). Red line shows gravel/sand interface.

Lowering of sand levels at this location was also noted in the December 2018 monitoring reports. This trend is ongoing and is likely the result of ongoing easterly transport of the dredged material placed here during construction.

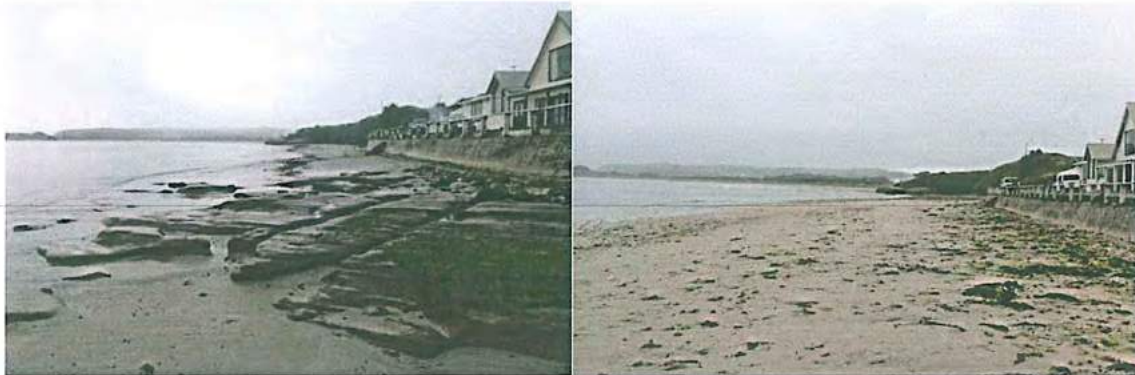
The main difference noted in previous monitoring rounds since construction was to the sand levels at monitoring point 3 along central and eastern end of Town Beach. Here the underlying tuff rock was seen to be exposed during the latter half of 2016, then being covered by sand throughout 2018-2019 (refer Figure 3-4). This difference appeared to be a direct result of the dredged sand placed west of this location in front of the fish factory in the latter half of 2016 being transported along the length of beach in front of the Hotel. The volume of beach sand placed on the Town Beach averaged over the area of the western half of the beach (including the area in front of the fish factory) equates to an approximate average depth of 0.5m. This is approximately equal to the maximum depth of sand surveyed following the sand placement indicating a large volume of the placed material was relatively rapidly incorporated into the beach system and dispersed along the beach eastward.

It is still not clear what the natural beach fluctuation will be along this length of beach based on the monitoring to date as there is only two years of monitoring since nourishment was completed. However, the Tuff rock in front of the hotel is still not visible during the 2020 monitoring round (refer Figure 3-4) which indicates the sand has withstood over four year's climatic cycles.

Figure 3-4: Beach photo-point monitoring at point 3 June 2016 (left) and Dec 2020 (right)

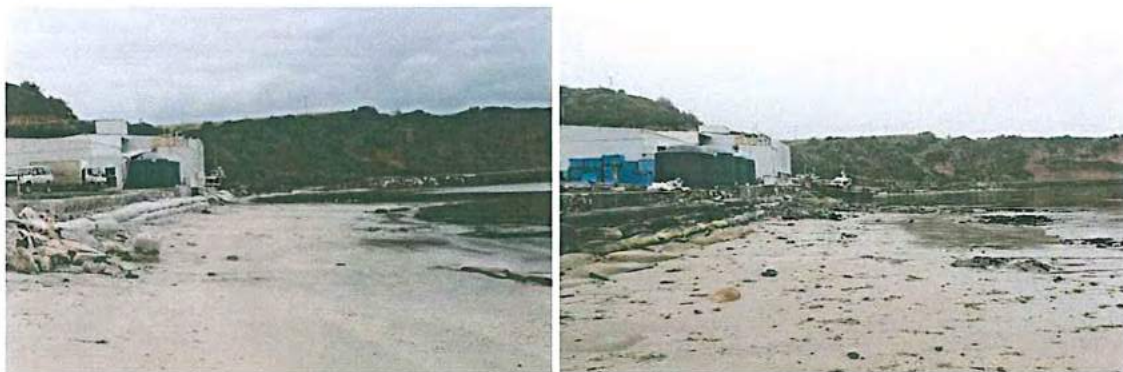
Figure 3-5: Exposed Tuff rock and gravel in front of the fish factory, Feb 17 (left) and Dec 20 (right).

Even though the Tuff rock in front of the Hotel is still covered, the beach levels to the west of monitoring point 3 have been lowering since 2017, exposing more gravel and Tuff rock seaward of the fish factory seawall (refer Figure 3-5). This ongoing trend is also evident between 2019 and 2020 with more Tuff rock exposed this year (refer Figure 3-17).

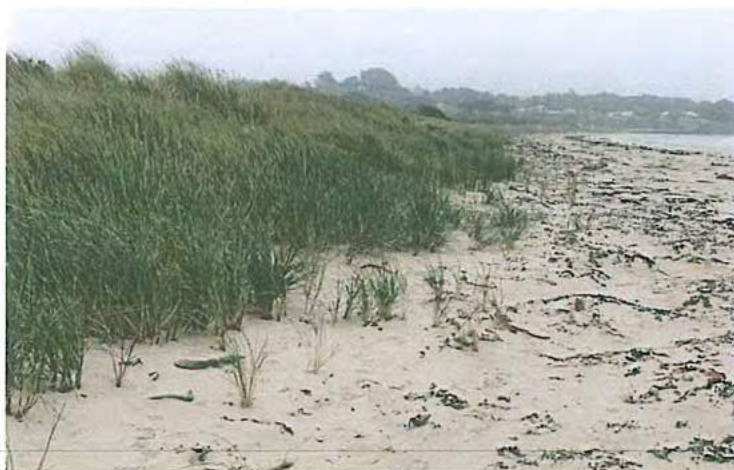
There are no obvious areas of increased beach or dune erosion visible in the monitoring photos along the length of beach 1-2km to the north of the Nairn River which has experienced background erosion since 1969. There was, however, signs of dune accretion around P6 and P7. Dunal vegetation was noted establishing further seaward than the dune toe (refer Figure 3-6) which is evidence of a less disturbed environment along the dune edge. This could be the result of several factors including:

- a Reduced storminess resulting in less erosion.
- b Increased beach levels seaward of the dunes providing some additional buffer from wave runup.
- c Increased sediment supply in the beach system at this location leading to increased deposition and dune accretion.

Figure 3-6: Dunal vegetation becoming established at the dune toe at P7

This is in line with a general dunal accretional trend noted at T4 and T5 discussed further in Section 3.3. There are also some additional minor changes noted along the beach north of the Nairn River in the survey profile monitoring section.

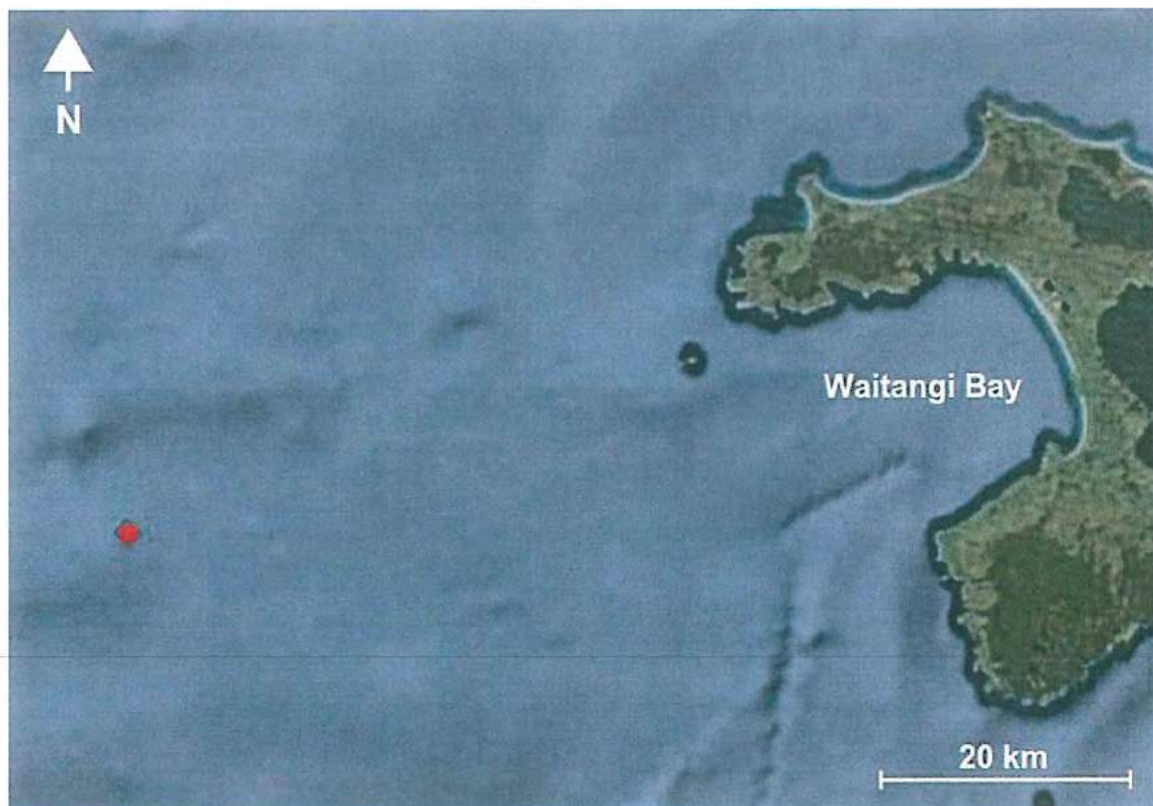
Wave data has been obtained from NOAA Wavewatch III (WW3) global numerical wave model at an output location 75km offshore from Waitangi Bay (refer Figure 3-13). The purpose of obtaining this wave data is to provide an indication of ocean conditions occurring between surveys (i.e. magnitude and frequency of storms). An understanding of these conditions is useful particularly when assessing any unexpected erosional or accretional trends that may be noted through any of the monitoring undertaken.

Figure 3-13: Location of numerical wave output point 75km offshore of Waitangi Bay

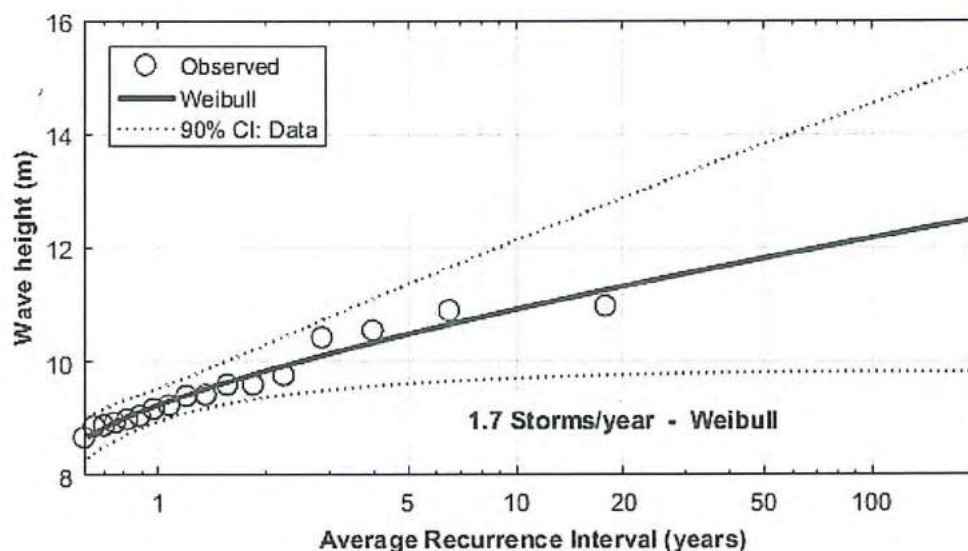
the purpose of this assessment this gives a good reference for discussion of the large wave events experienced during the analysis period.

Figure 3-15: Weibull extreme value analysis undertaken on the pre-construction wave dataset (2005-2015).

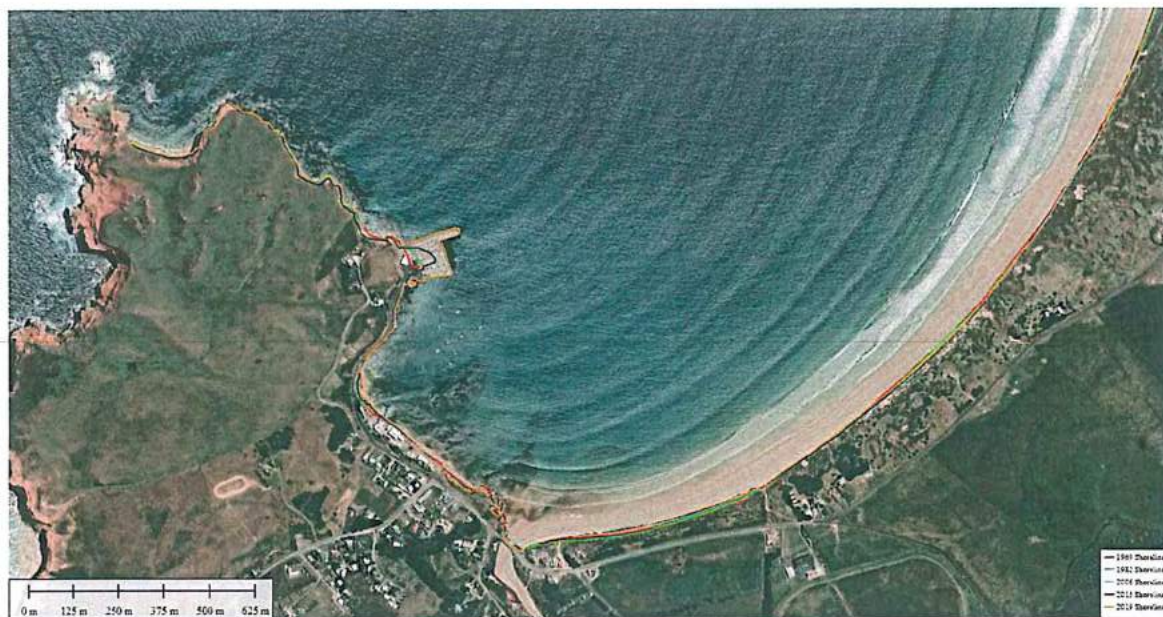
Figure 3-16: Shorelines from 1969, 1989, 1996 and 2013 images superimposed on 2013 satellite image (source CNES/Astrium)

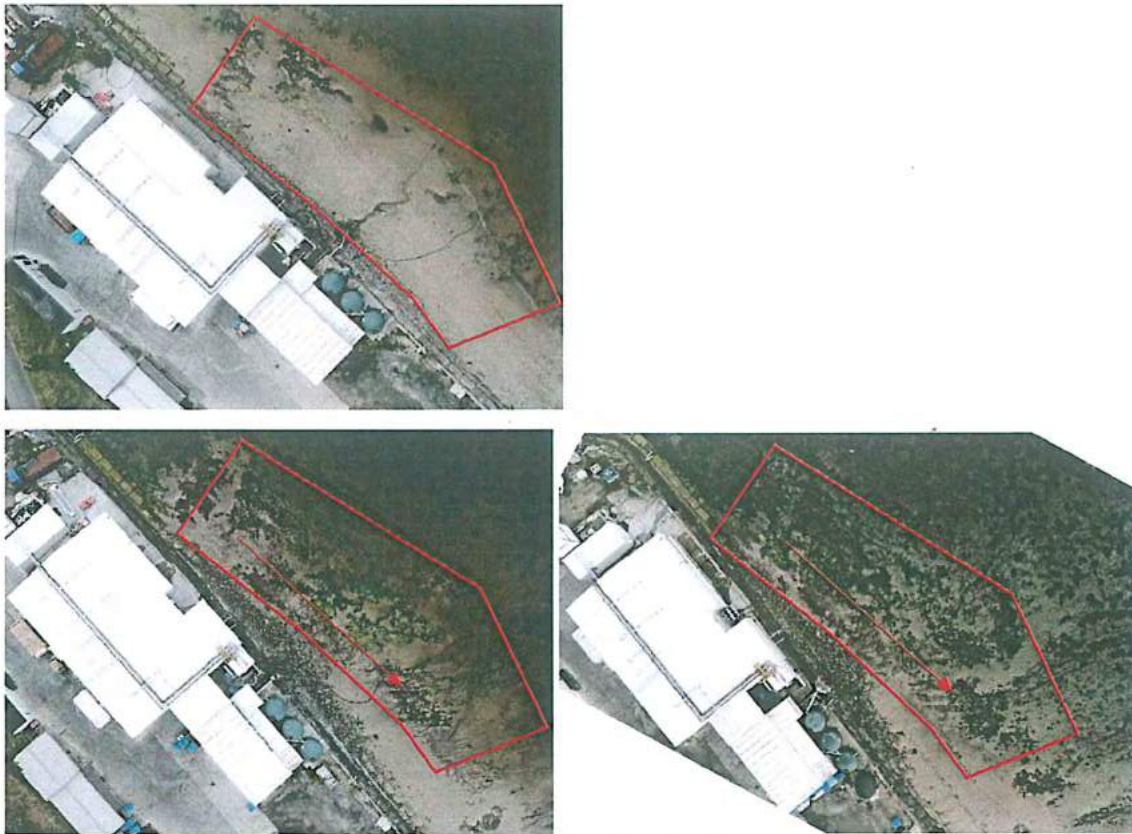
IN the interim, Unmanned Aerial Vehicle (UAV) aerial photography has also been taken along Town Beach and part of the beach north of the Nairn River (2016-2020) and has been visually assessed for any notable changes in shoreline and beach profile (refer Figure 3-17). Comparing November 2019 and December 2020 aerial photography of Town Beach reflects the analysis in Sections 3.2 and 3.3 in that there is some lowering of sand level (or increased area of exposed Tuff rock) since the 2019 along the monitoring round in front of the fish factory.

Figure 3-17: UAV photo analysis showing differences in Town Beach sand levels in front of the fish factory between Dec 2018 (top), Nov 2019 (bottom left) and Dec 2020 (bottom right). Arrow shows general easterly movement of sand.

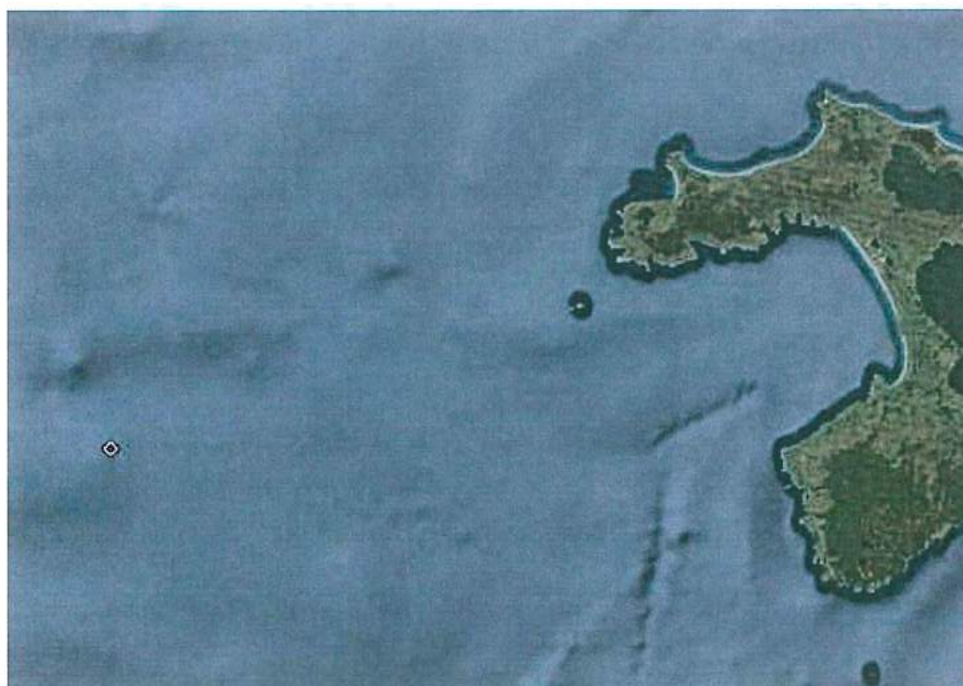
Information will be collected on the wave climate reaching Waitangi Bay. This information will be obtained from NOAA Wavewatch III global numerical wave model at an output location 75 km offshore of Waitangi Bay (Figure 3). This output will provide indication of ocean conditions occurring between surveys (i.e. magnitude and frequency of storms).

Figure 3 Proposed location of numerical wave output point offshore of Waitangi Bay

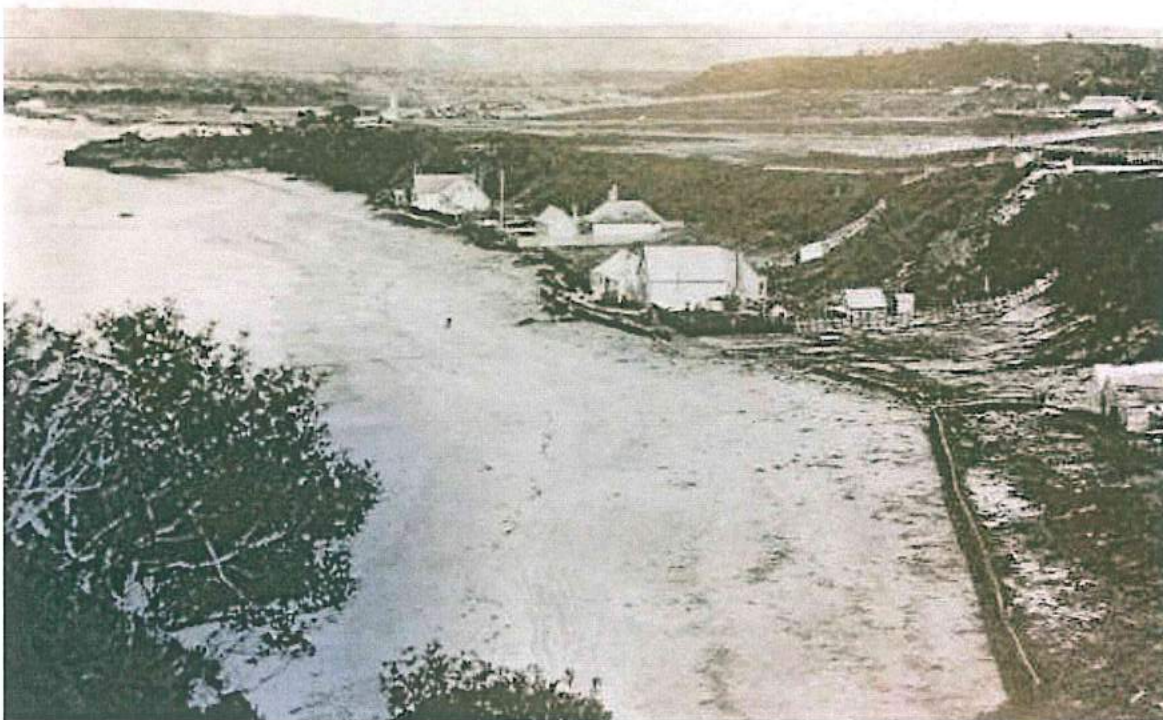
Early imagery of Waitangi Town Beach (Figure 2- 5 and Figure 2- 6) show buildings constructed on the low terrace at the base of the tuff embankment. Timber and brush seawalls fronting the land are also evident and were reported as being intended to prevent erosion (King and Morrison, 1990). This indicates that although a wider beach is evident than exists there today, periodic erosion was an issue then.

Figure 2-5 Waitangi circa 1870s (Source: Canterbury Museum in. King, M. and Morrison, R., 1990. A Land Apart)

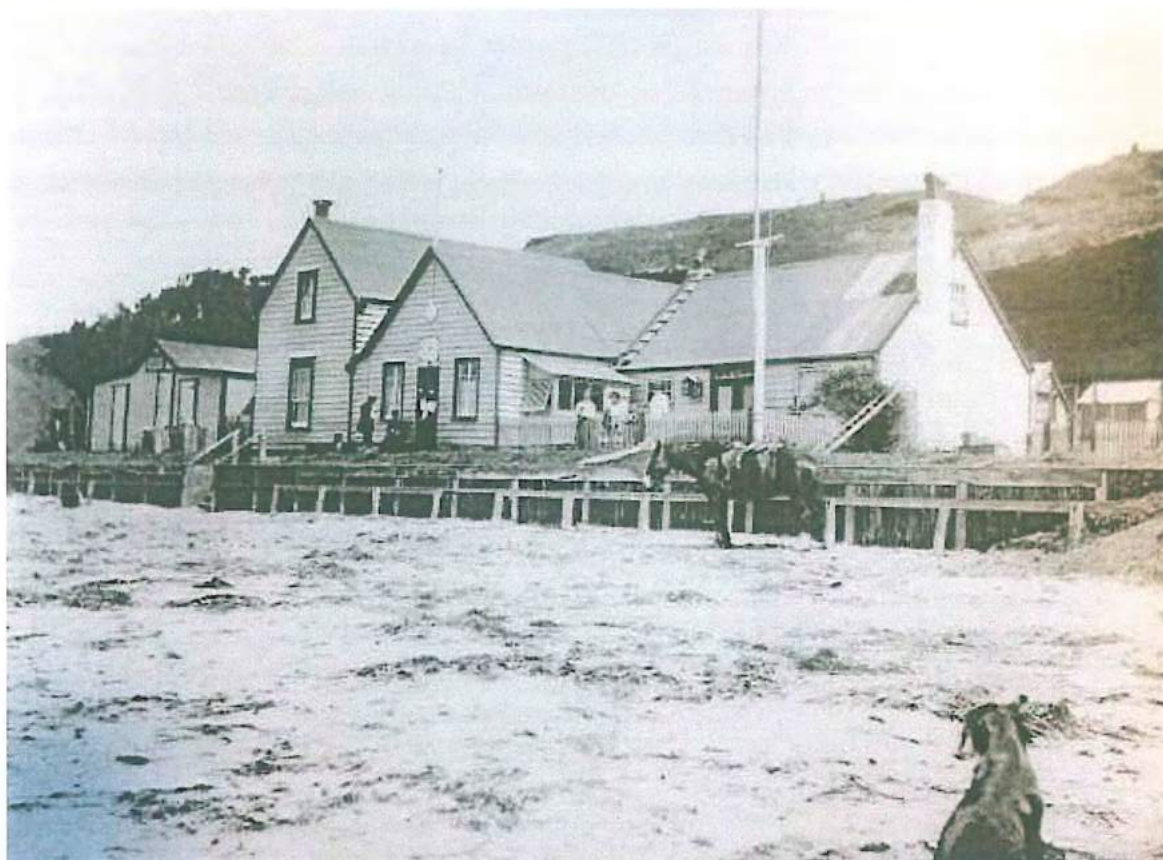
Figure 2-6 Beach fronting the Mangoutu Hotel circa 1910 (precursor to the Waitangi Hotel constructed in 1956)
(Source: Guest Collection, Alexander Turnbull Library in. King, M. and Morrison, R., 1990. A Land Apart)

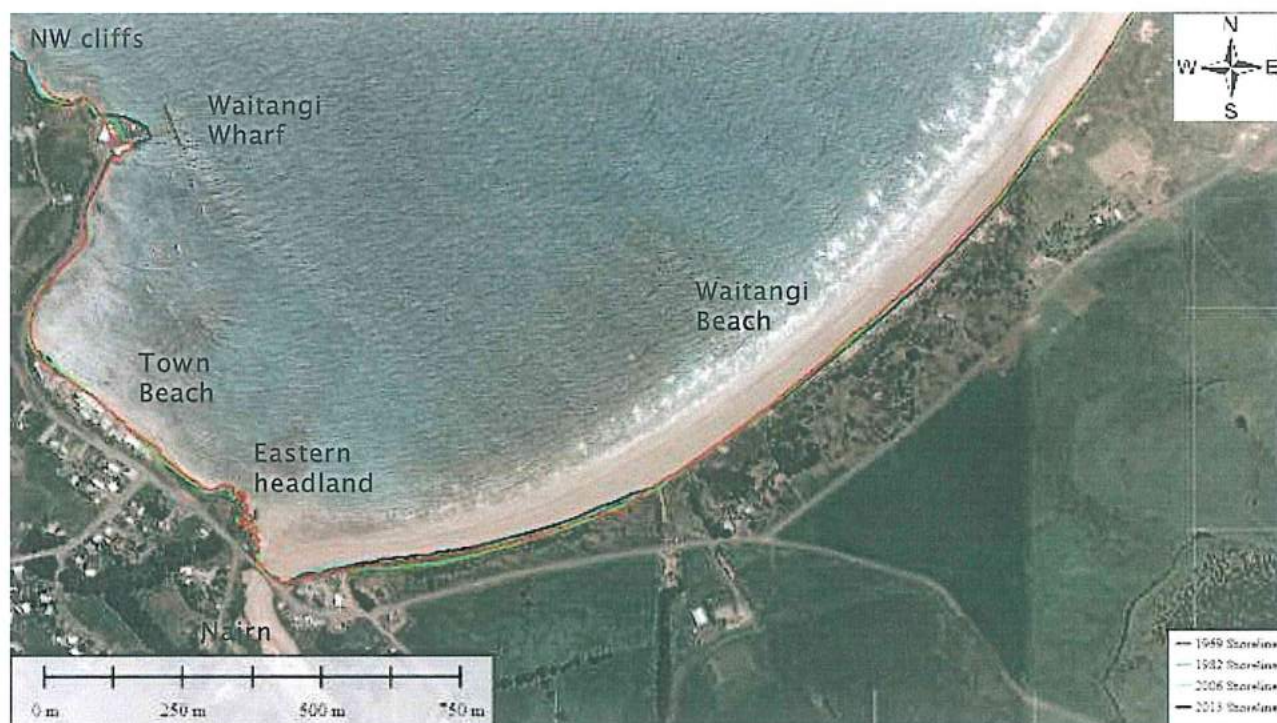
Figure 2-7 Example of historic shoreline positions superimposed on the 2013 Satellite Image

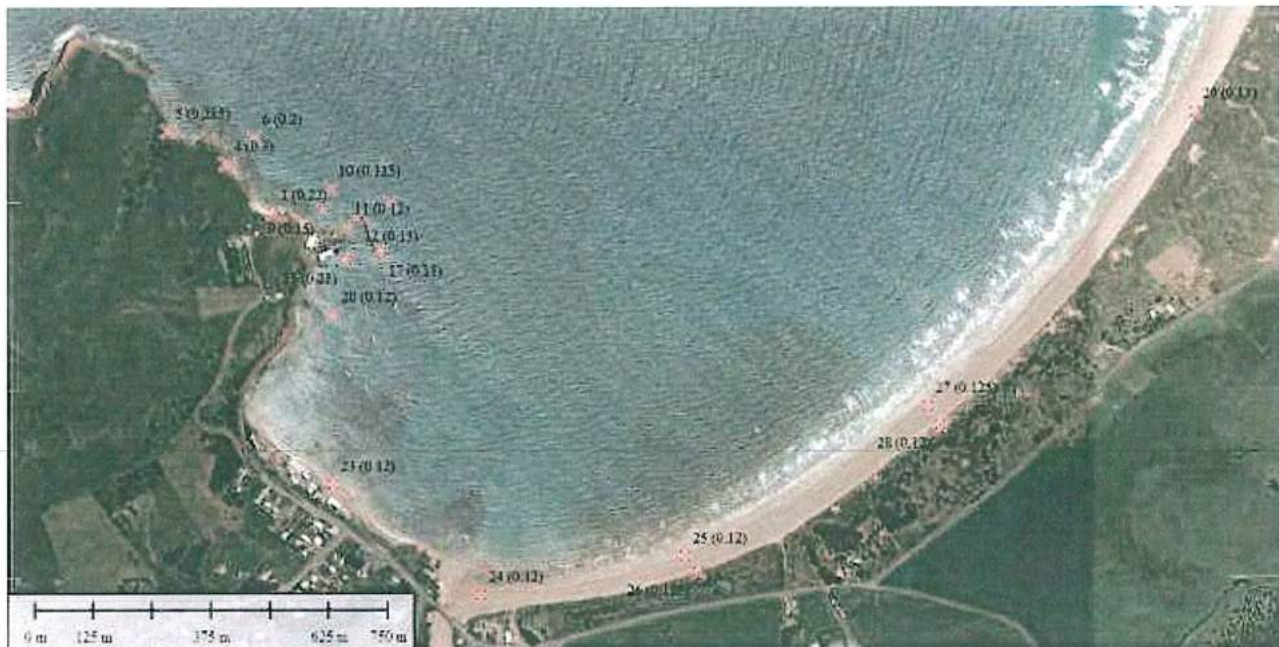
Figure 2-9 Sediment sample numbered locations and median size (D_{50}) in mm.

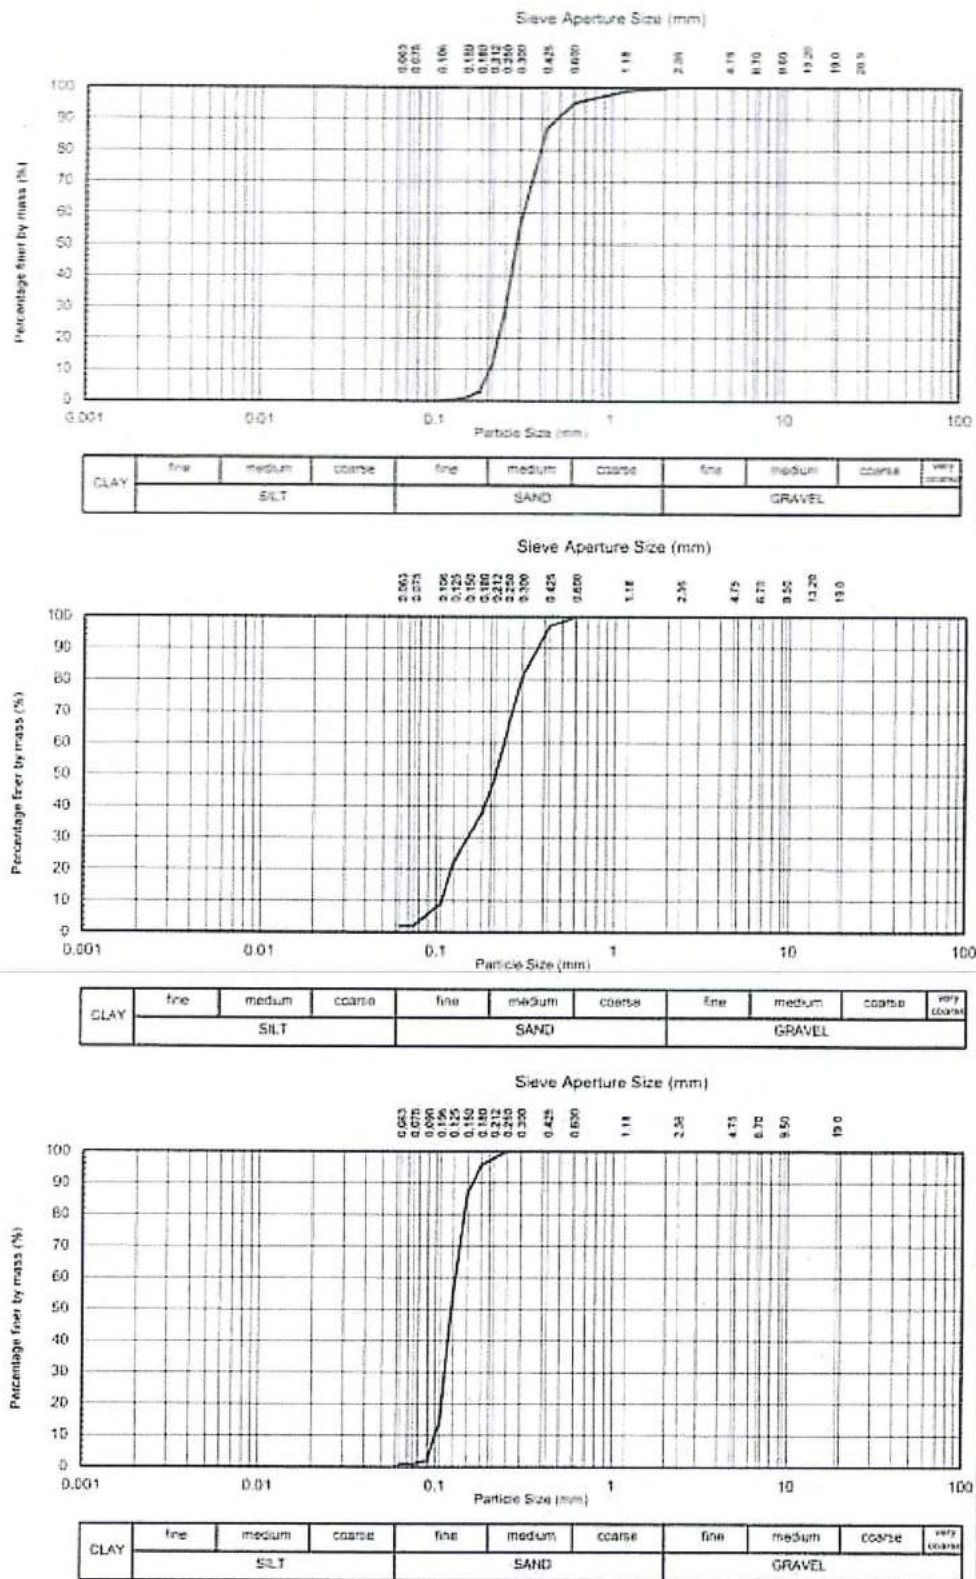
Figure 2-10 Example of sediment gradings from the base of the sea cliffs northwest of the breakwater (top; Sample 5, $D_{50} = 0.28\text{mm}$), at the end of the wharf (centre; Sample 15, $D_{50} = 0.21\text{mm}$) and 500m along Waitangi Beach (bottom; Sample 25, $D_{50} = 0.125\text{mm}$)

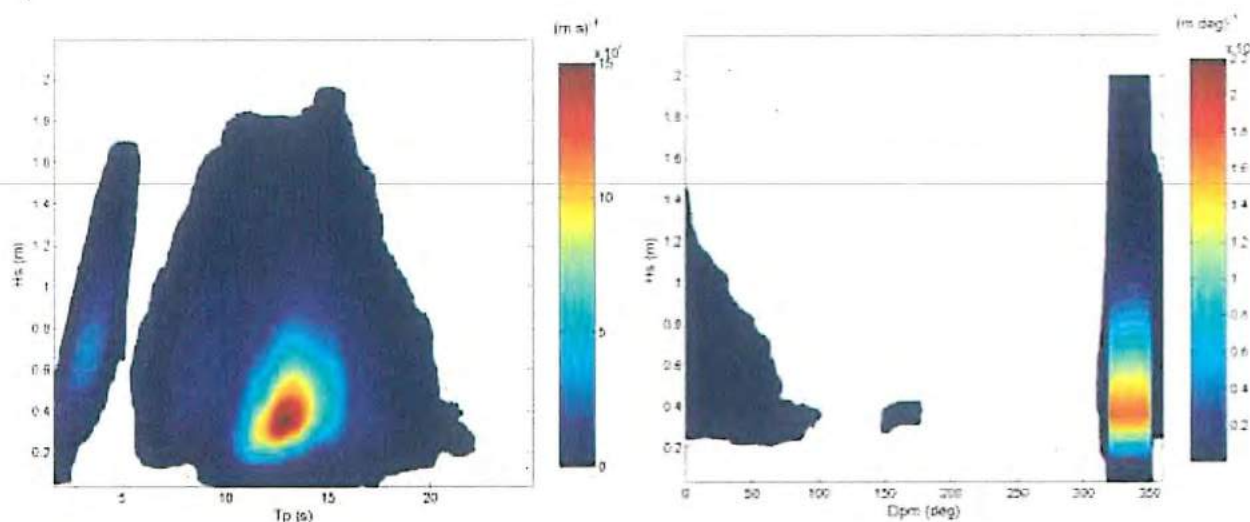
Figure 2-17: Density plot of total significant wave height vs peak wave period (left) and significant wave height vs peak wave direction (right) at outpoint point S06 (source: Metocean, 2015a)

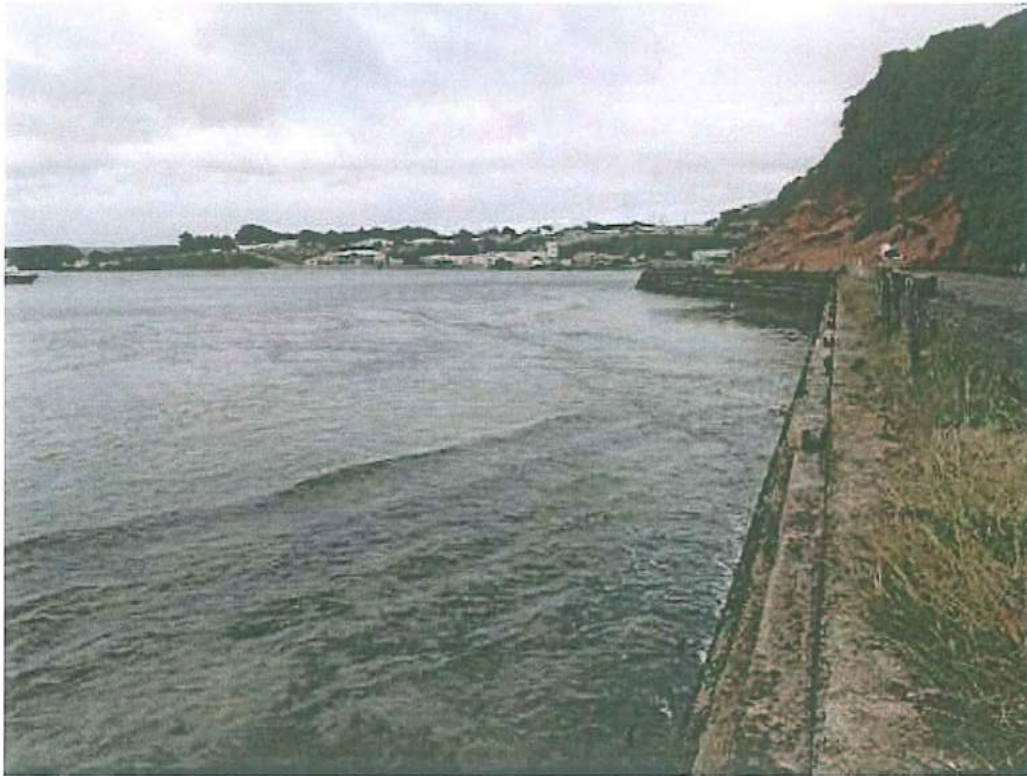
Reflection off the seawall can be observed during high water levels. This reflection deflects waves that have refracted around the existing reclamation and are approaching from a northeast direction towards the beach from a northwest direction. While this has only been observed in relatively benign conditions, similar reflection reportedly occurs during high energy conditions.

Figure 2-19 Road seawall reflecting oblique incoming waves towards the beach

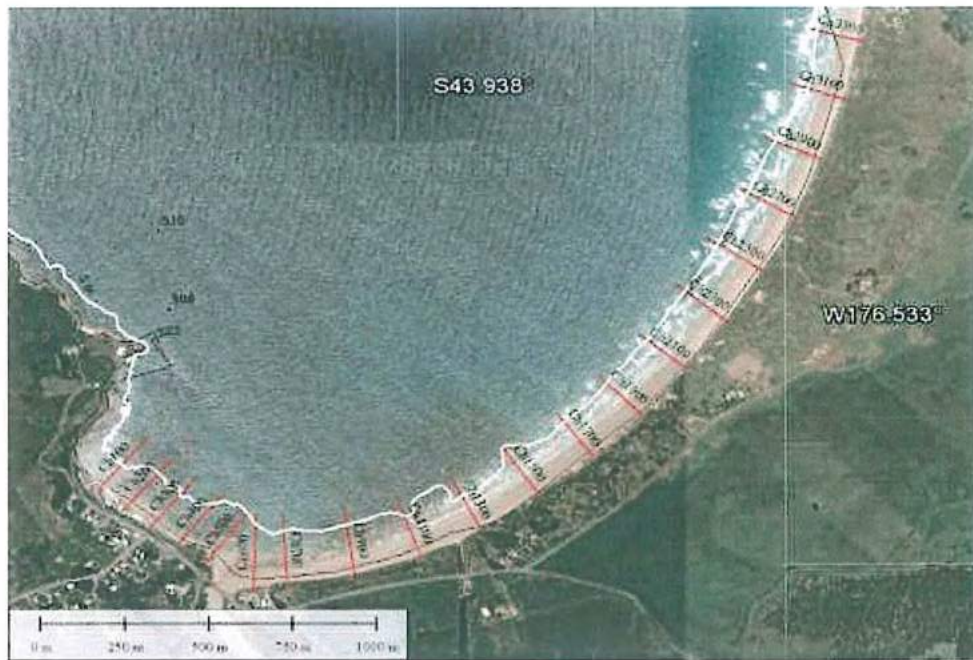
Figure 2-21 Output points around Waitangi Bay at chainage distances from the western end of the beach (top) and the resultant 1% AEP wave height at the 2m depth contour and derived wave runoff and setup (lower)

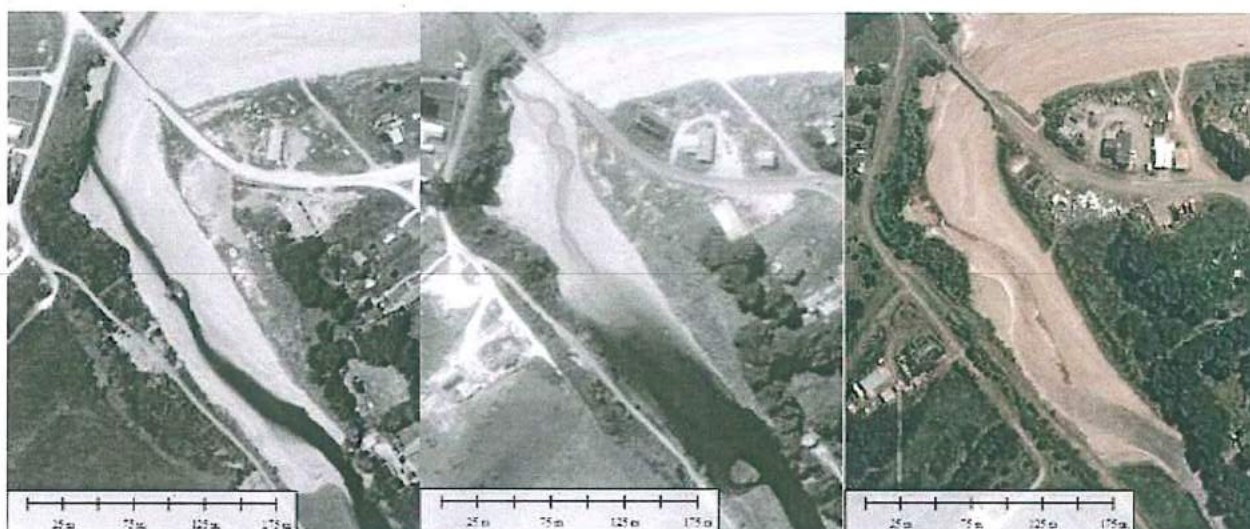
Figure 2-24 Example of sediment accumulated in the lower Nairn River in 1969 (left), 1982 (centre) and 2013 (right)

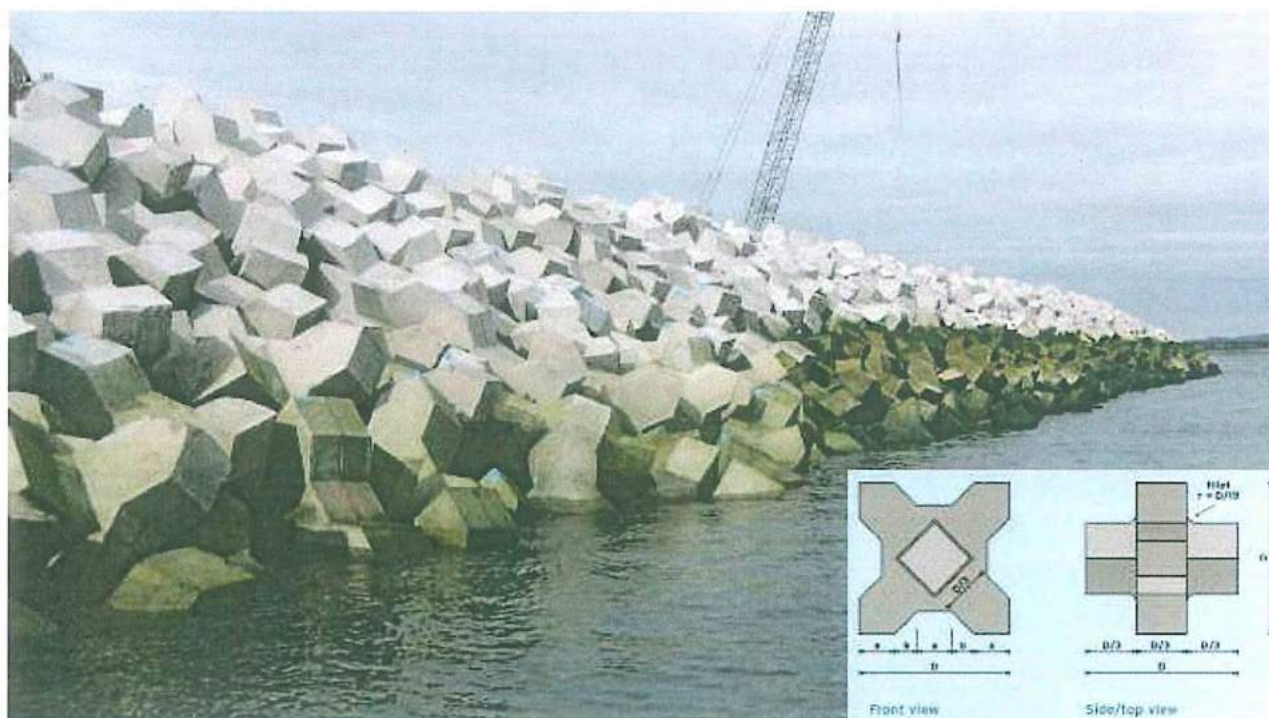
Figure 3-2 Example of breakwater constructed using Xbloc armour units (source: DMC, 2013)

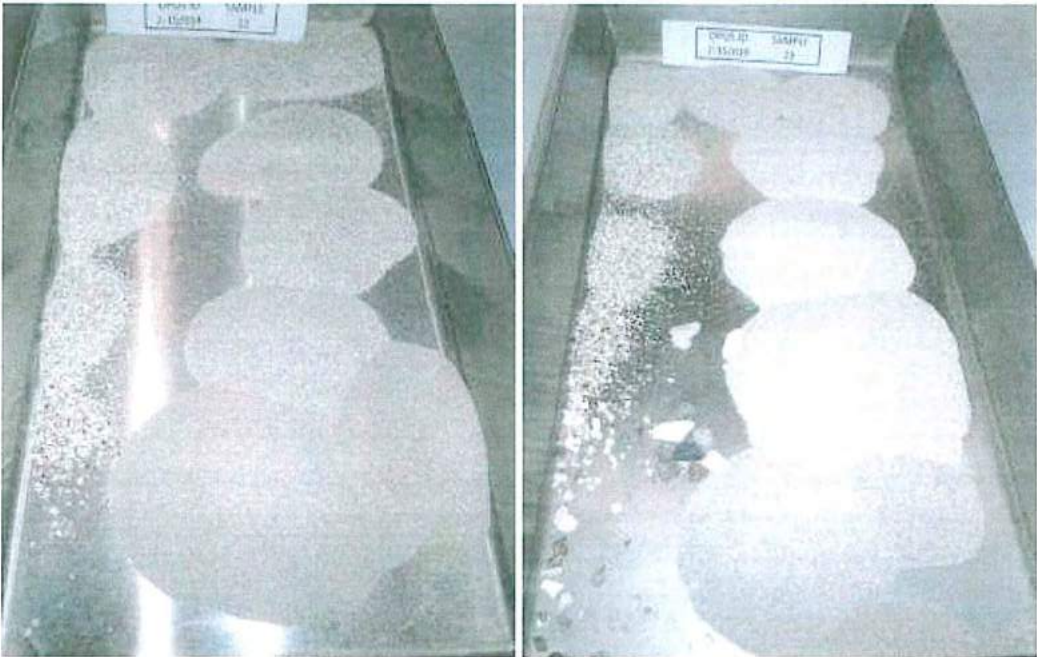
Figure 3-3 Comparison of proposed replenishment sediment (left) with existing beach material (right)

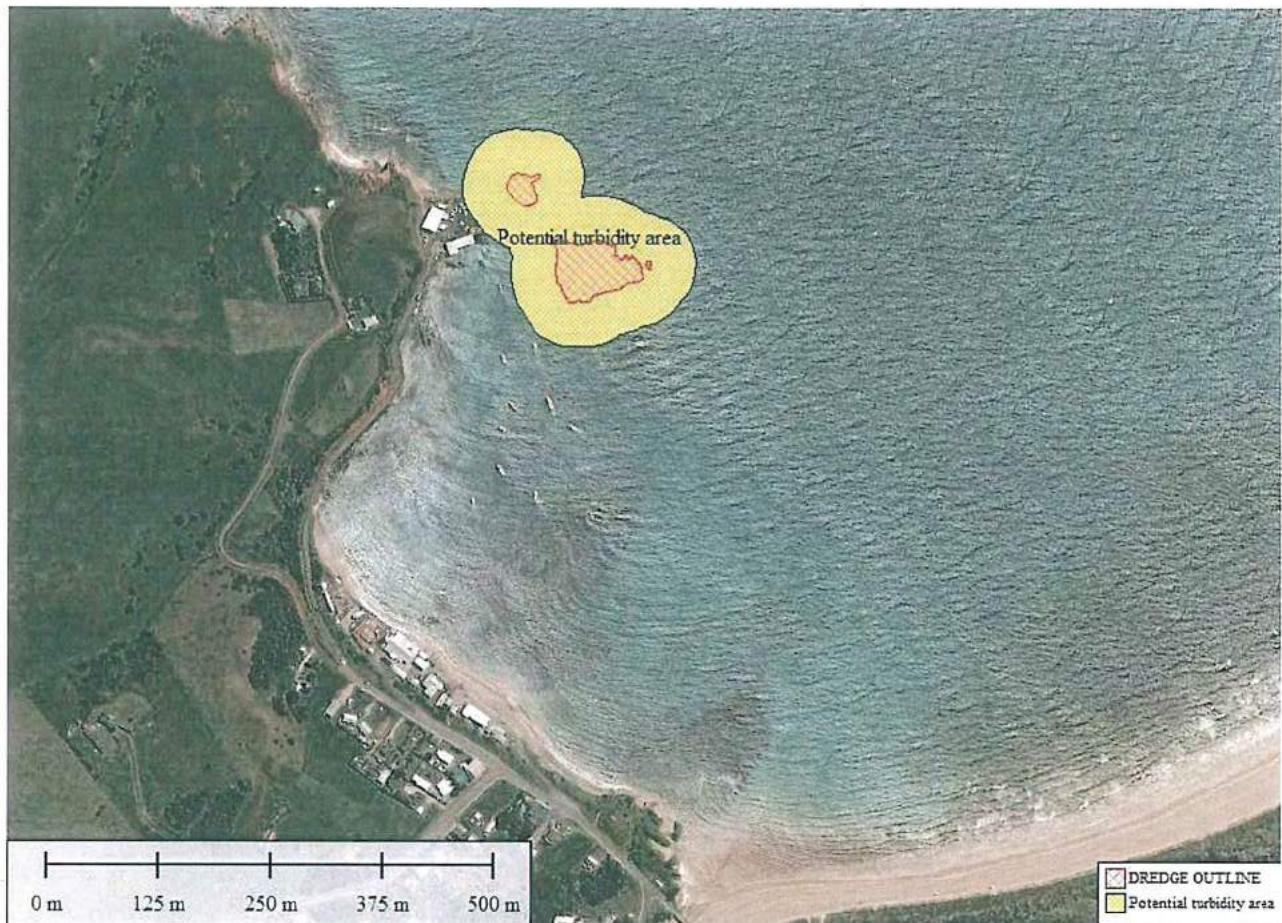
Figure 4-11 Area anticipated to be affected by turbidity during dredging
